# City of Minnetonka retains native bur oak following risk assessment of existing conditions, and subsequent storm damage, in 2014.

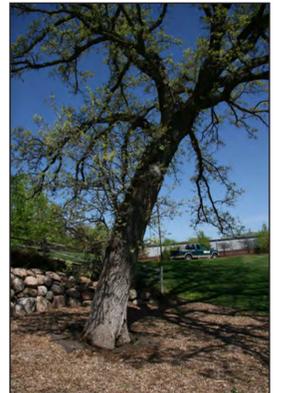
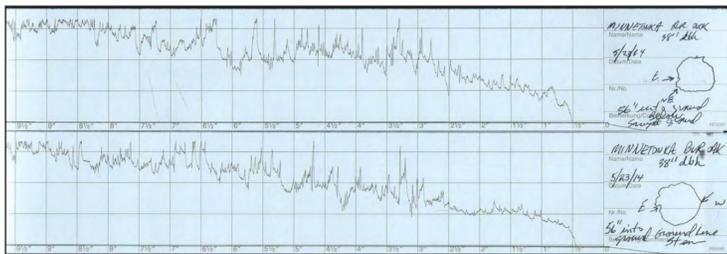
**Decay Evaluation:** Probing through the opening reveals an internal cavity of at least 30". Following excavation the lower stem wood entering the ground and above passes a sounding test. Knowing the material strength and decay resistance of this species, the evaluation could have ended here. There was no detection of significant decay, which would have produced a dull vs a sharp sound. To be assured of the results of the sounding, and for documentation given the location of this oak, Resistograph samples were taken.

The two Resistograph samples to the left were stopped at 9.5 to 10" depth. **There was no need to go any further. No wood decay was detected along the sample and the existing internal void was not reached or breached.** Given a stem diameter of 56" at this level of cross-section, and 1/2 inch of bark, the stem radius would be about 27". The sample validates at least a greater than 30% t/R remaining wall. This would easily be 15% of diameter at each sample point. **Given the very large bearing capacity (size), of this cross-section, material strength and decay resistance of this species, and applying years of experience, it would be our opinion; this oak would have been relatively safe with 5" of sound wood or a 20% remaining wall!**

**The Risk Rating: Lower stem decay; risk of failure (using the ISA Risk Rating Matrix) from decay;** the likelihood of stem failure from internal decay is **improbable** (the tree is not likely to fail during normal weather conditions and may not fail in many severe weather conditions). With information gathered from the managers the site occupancy was determined to be low, (the site is used a few times a week between June and September for 5-6 hours). The likelihood of tree failure impacting a specific target is Unlikely. The consequences of failure can be interpreted as minor (low to moderate property damage and small disruptions to people moving to minor injury), given the improbable likelihood, and even with potential *significant consequences*, **the risk rating for this condition is low.**

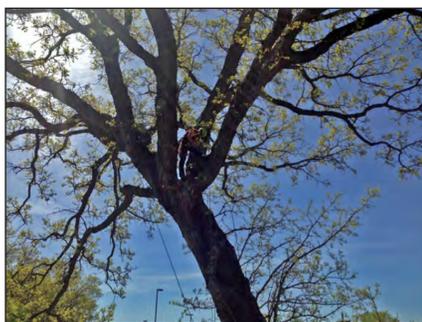
**Branch attachments;** a stem inclusion high up on the west side, extends out of site into the union to the left.

The aerial inspection finds the inclusion extends into the union and is open, just to the left, (west) of the climber's right foot (see image to right).

**The Risk Rating: Branch attachment, risk of branch failure from inclusion;** the likelihood of one of the northwest leads failing is **possible** (failure could occur, but is unlikely during normal weather conditions) and with *minor consequences* (low to moderate property damage and small disruptions to people moving to minor injury), **therefore the risk rating for this target area is low.** Additionally, the likelihood of the branch reaching the road, just west is unlikely. **This defect now becomes condition # one in the report/findings.**
