## **2011 Safe Trees, LLC, Tree Risk Assessment (Hazard Tree) Workshop Report.**

### **Safe Trees, LLC is a Hayes Tree, LLC Company.**

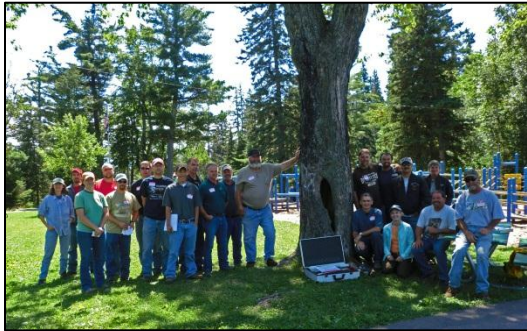
A workshop group photo with the park silver maple. The lower stem in the maple has an average 10% of diameter remaining wall or a 20% t/R (sound wood shell/to radius) ratio. The city of Duluth in this case decided that given the maple is not in eminent danger of failing they will replace the tree when the play area in the background is replaced. They now understand that given the species profile and stem form; there is a greater probability of a branch shed than what would be a rare stem failure.

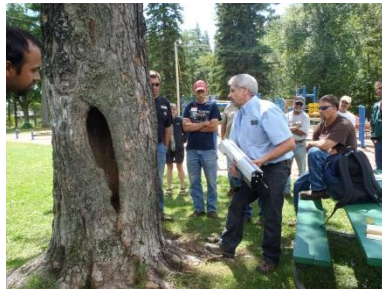
Ed Hayes finishing a demo sample with an F-400 Resistograph of the south side of the maple's lower stem. Removal in time was the recommendation for this maple. Both easy and advanced decay detection tools are used during the field training. Attendees have the opportunity in the field to make assessment decisions and try out the tools, this photo by Levy Tree, Duluth, MN.

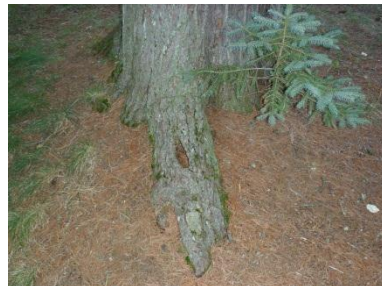
A large white pine with good exposed buttress root flares and obvious positive indicator of root decay, the cavity opening. This tree did fail the root decay assessment (more than 2 of 3 root flares had significantly less sound wood than a 15% of diameter (dbh) guideline). Lucky, this pine is located inside the edge of the woods with crown protection from other pines and away from target areas, this photo by Levy Tree, Duluth, MN.

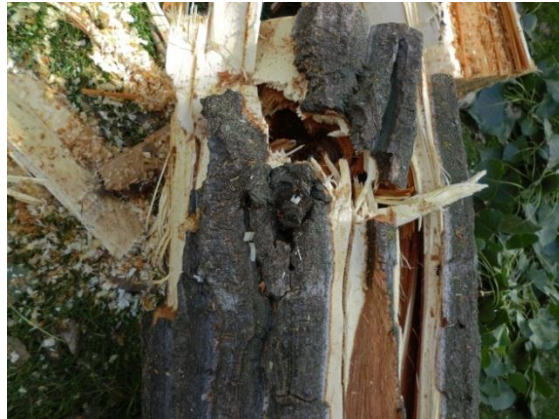
The photo just to the upper right revealed a surprising high amount wood decay that is developing in branches and stems of the E. cottonwoods Populus deltoides in this park from just small dead branches, all to be incorporated into their risk assessment surveys.

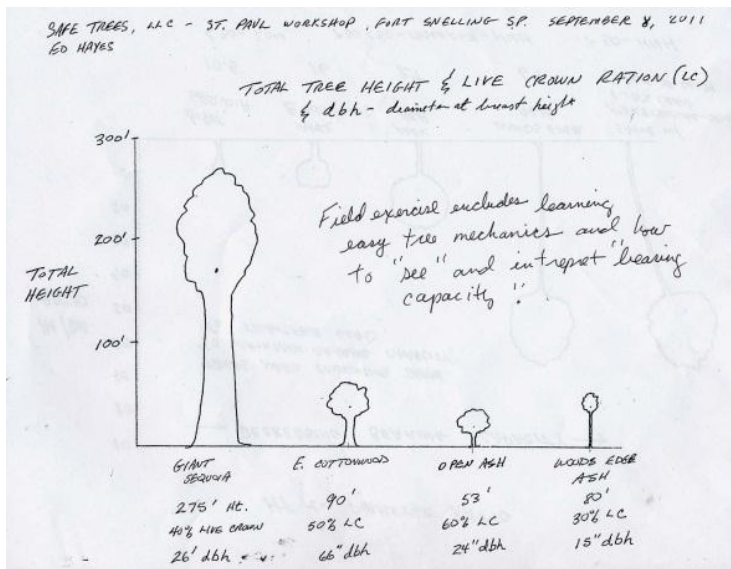
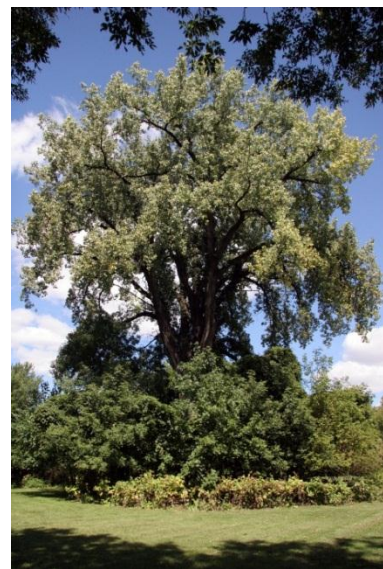
In the images above note the massive E. Cottonwood has developed enormous lower stem bearing capacity based on its height and greater than a five foot lower stem diameter cross-section. Its eventual mode of failure then is dependent on the soundness of its lower stem, roots, and defined by its decurrent stem form and its noteworthy species failure profile.

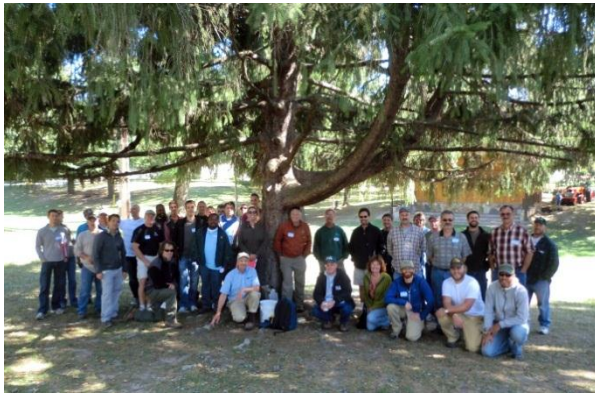
A workshop group photo with the park Norway spruce, a terrific example for a discussion of responsive (adaptive) growth.

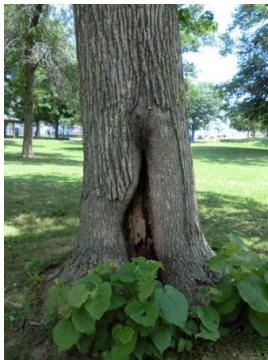
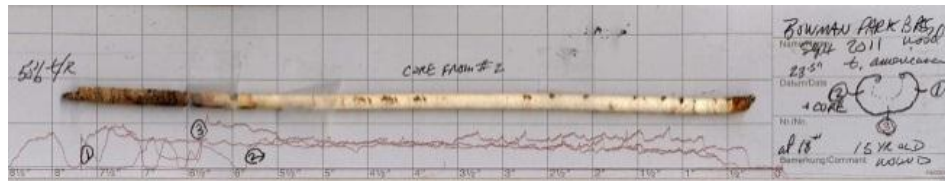
Above, the roughly 35 year old Bowman Park American basswood Tilia americana. This park tree sustained a lower stem wound during an auto accident about 17 years ago. A car out of control entered the park and propelled a picnic table into its lower stem, wow, (a personal communication with city staff). The class decay evaluation discovered a relatively consistent 10% of diameter or 20% t/R ratio sound wood remaining wall around the lower stem central column of decay. The risk of failure of this basswood stem from the lower stem defect (decay) is improbable under all but extreme weather conditions. Its prognosis can improve over time even

if the ratio of sound wood remains the same as the tree continues to add bearing capacity, (secondary growth).

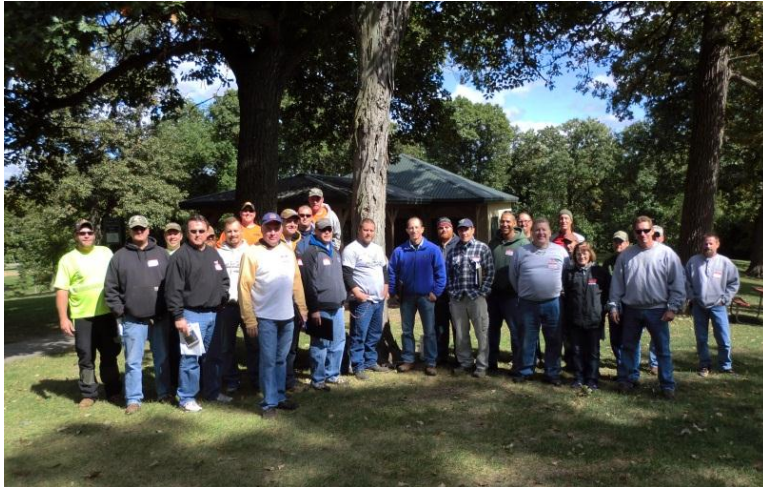
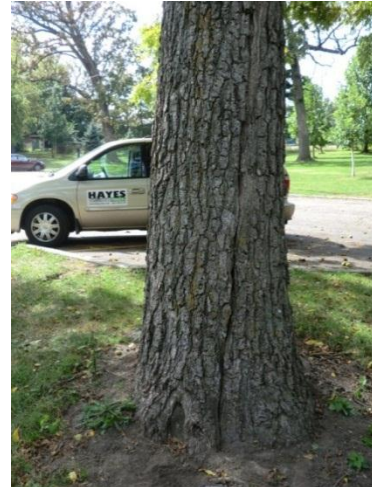
Above the Des Moines workshop group photo and the workshop decay evaluation tree. The above E. Black walnut *Juglans nigra* has only a 5% of diameter or 10% t/R ratio of sound wood in the lower stem. The tree is in poor condition due to long term site stress, removal was the recommendation.

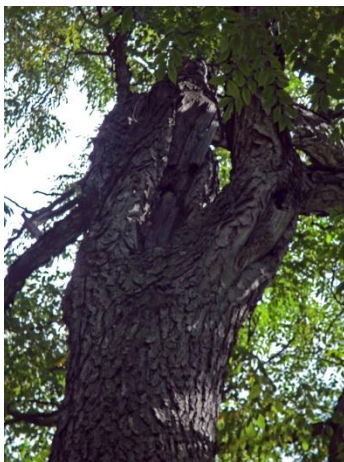
Note the old wounds on this E. Black walnut, are showing very good responsive growth as extra wood is added around the cavity openings. Black walnut trees have good resistance to wood decay and this particular tree appears to be in good condition.
