# City of Minnetonka retains native bur oak following risk assessment of existing conditions, and subsequent storm damage, in 2014.

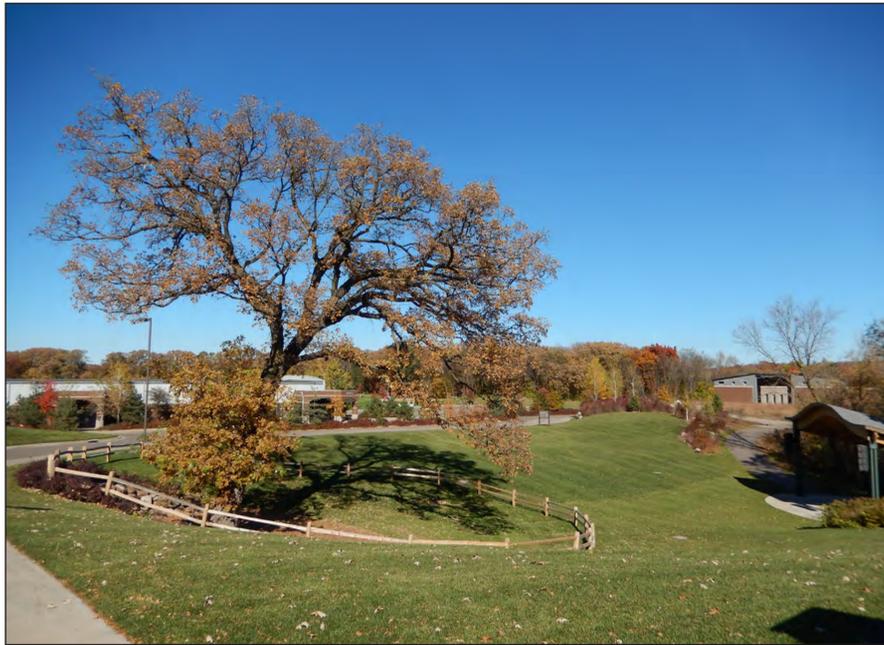
A two hundred year old bur oak shades the amphitheater grounds for music events at a city campus. Over time small dead wood branch sheds, a lean, and signs of decay inspire a closer look.

**Initial Inspection May 23, 2014;** the potential conditions (defects), included the lean, lower stem and or root decay, and weak attachments above given the multiple leads.

**Lean:** The lean is a natural, corrected, 20% lean to the east.

**Wood Decay:** There is a positive sign of internal wood decay, the cavity opening.

The oak has a diameter of 38", (dbh, or diameter at breast height, 4.5' above ground). However, it enters the ground, (where the decay is of issue), with a diameter of 56"!

**Mitigation; Low-risk trees may not require any mitigation and should be retained and monitored (if appropriate), and at the discretion of the owner.** If mitigation is recommended the priority is low and would be appropriate when budgets, work schedules and other considerations allow. Recommendations were made for a light crown reduction and health care should the city retain the oak.

On August 7, 2014 the Leadership Team of the City of Minnetonka, made a decision to retain the oak with the following conditions: (1) a split rail fence would be installed around the tree. (2) an interpretive sign would detail the oak's condition and provide cautionary statements.

On October 15, 2014 the oak was treated with Cambistat for long term site stress. Any future Cambistat treatments would need to be based on tree condition over time.
